# Environmental Monitoring Report

Report: Semestral Report

Reporting Period: 1 January to 30 June 2024

## Sri Lanka: Health System Enhancement Project

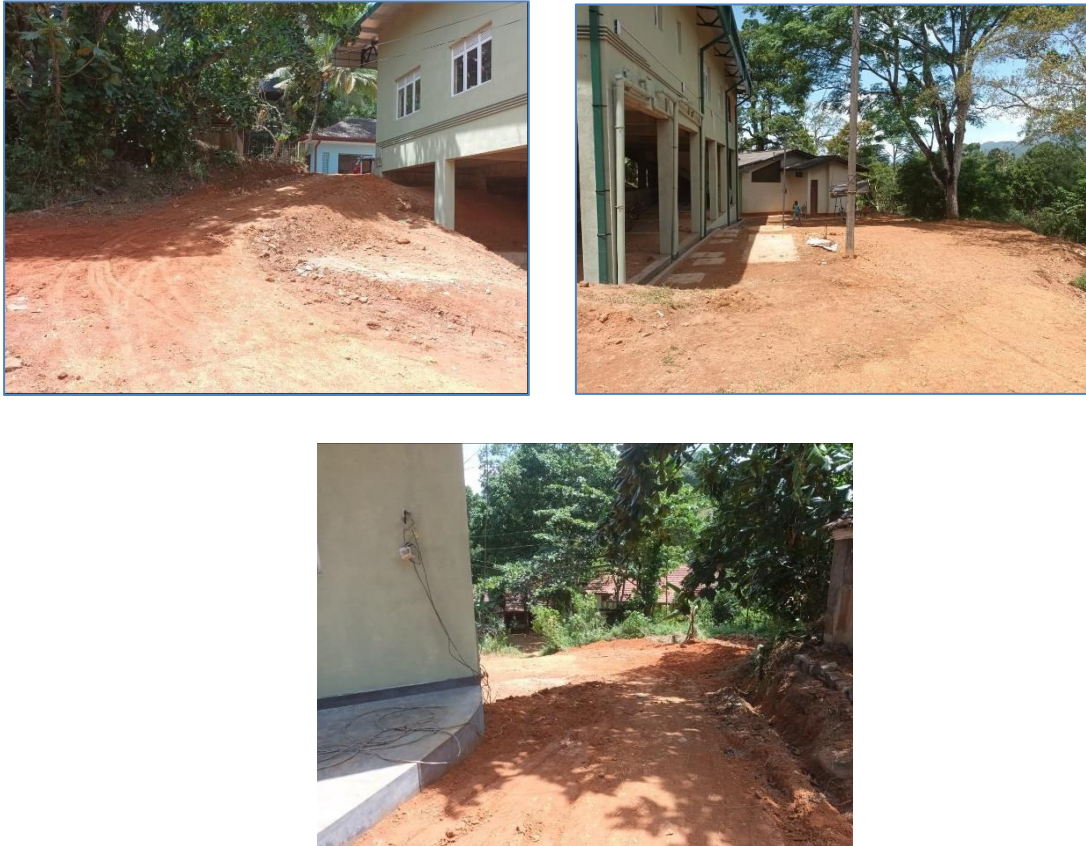
1. The construction of the access route to the MOH building has resulted in patients having to take a slippery concrete footpath to enter the building. This poses a significant threat and causes numerous difficulties, especially for pregnant women and children.

2. During the cutting and removal of trees, carelessness and irresponsibility led to damage to part of the roof of the MOH building, resulting in leaks. If the damaged and decayed ceiling falls onto patients, it could cause injuries.

4. The disorderly work of the contractor has blocked the drainage and rainwater canals with loose soil. As a result of poor drainage, stagnant water puddles have formed in front of the MOH building, causing a mosquito menace.

**Figure 4.2: The present condition near the new building and the MOH premises at Pinnawala**

69. The PIU, under instructions from the PMU, informed the contractor to strictly follow the instructions and immediately address the issues and rectify them. The contractor complied and made all the necessary corrective actions under the close supervision of the PIU Engineer and DSC Engineer. The Sri Lanka Public Health Inspector's Union – Rathnapura Branch sent a letter (dated 2024.06.09) appreciating the immediate and timely action taken by the PMU, PIU, RDC, and the contractor. Their letter of appreciation is attached (Annex 5).

- Ensure that the contractor employs proper construction techniques to prevent damage to adjacent buildings. Conduct regular quality checks and inspections by the DSC Engineer to monitor construction practices.

- Restore and repair the public amenities (children's park fixtures and fittings at Pinnawala) promptly.
- Ensure that any damage caused by construction activities is promptly addressed and repaired.

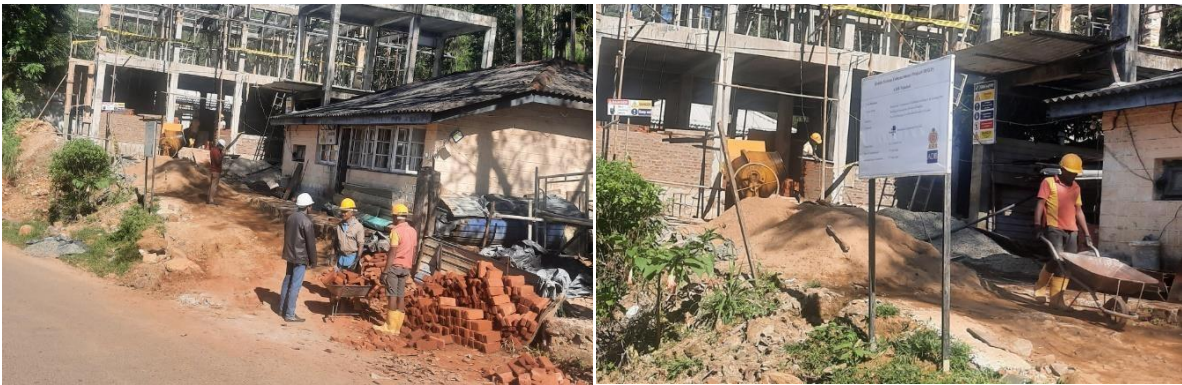
- (i) The incident that took place in Spring Valley could have been avoided if the workers had been properly supervised and instructed to wear appropriate PPE. Although such PPE has been provided, it appears that the workers do not comply with the strict requirements of adhering to health and safety standards. The Environmental Specialist noted that the workers were adopting safety measures at Spring Valley during his field visit to the site in January. However, on the day of the fatal accident, the workers had failed to comply with the safety measures by not wearing PPE.

**Figure \*\*: The photographs taken by the Environmental Specialist during his site visit on February 8, 2024 – just a week before the fatal accident occurred. It is noted here that the workers were wearing appropriate PPE (hard hats, gloves and boots). However, why the workers did not wear the PPE on the day of the fatal accident is not clear.**

79. To avoid such incidents in the future, the following corrective actions should be implemented:

- Perform periodic safety audits by the RDC Engineer and PIU Engineer to identify potential hazards and improve safety practices continuously.
- Ensure that all workers are provided with the necessary PPE and that replacements are readily available.

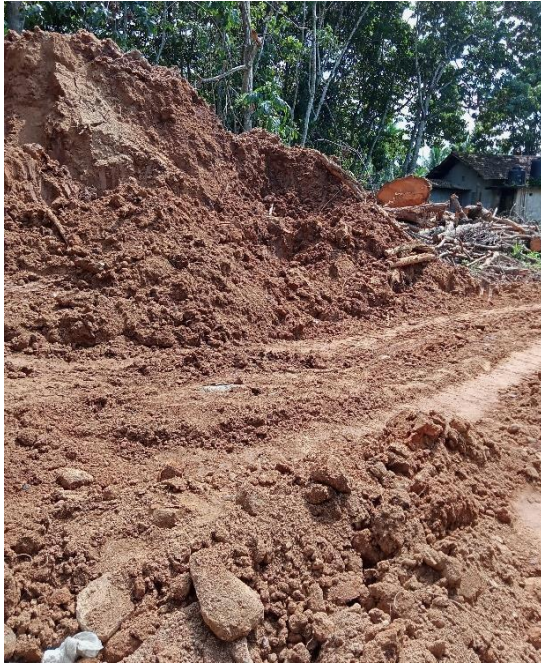
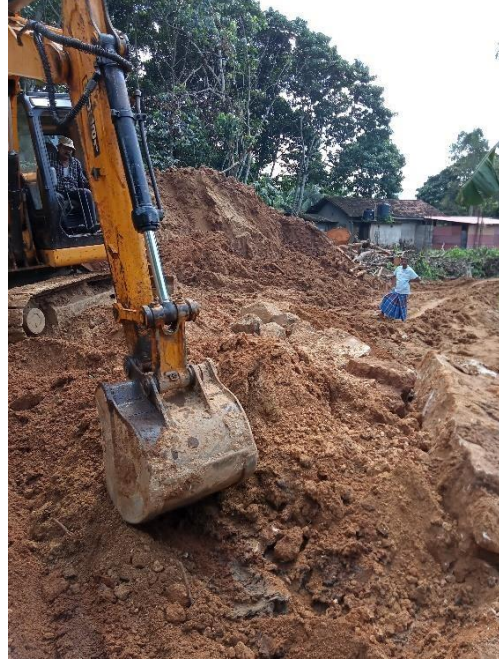
Annex 2a: Details of topsoil/debris disposal

Provide details of how debris and topsoil were disposed  
The rear side of the hospital premises

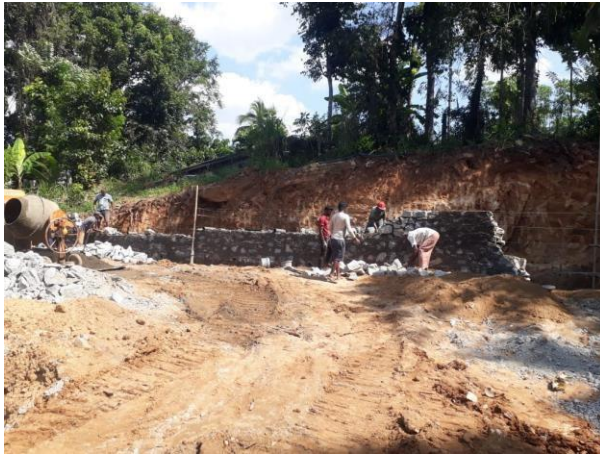
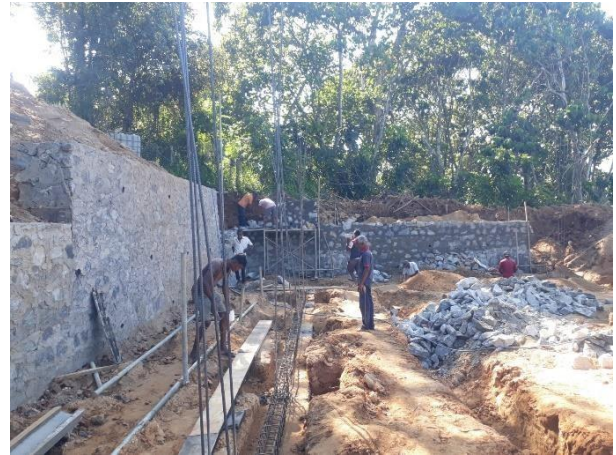
**Annex 5: Prevent soil collapsing by constructing a retaining wall.**
