# Environmental Monitoring Report

Report: Semestral Report

Reporting Period: 1 July to 31 December 2020

## Sri Lanka: Health System Enhancement Project

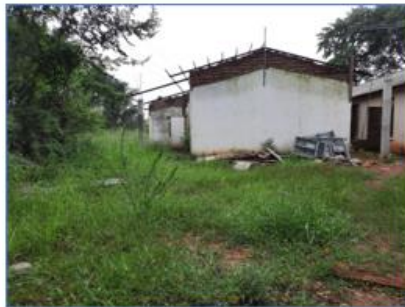
1. Look into the need to demolish part of the roof of the adjoining (existing building). Plan this in consultation with the hospital authorities and allow them time to schedule their work.

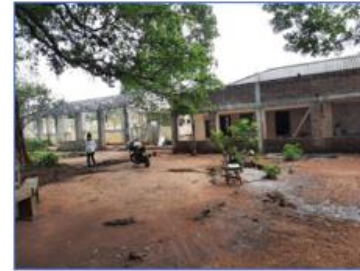
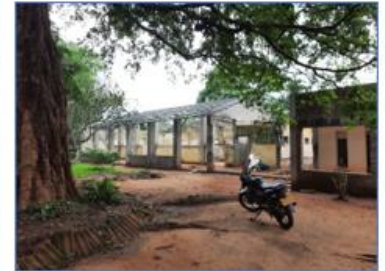
3. No dust barriers have been erected. The windows of the main building facing the project site should be covered appropriately with polyethene.

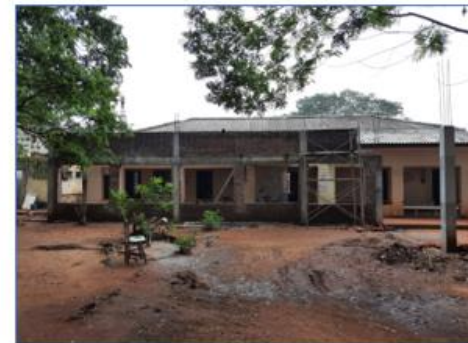
4. No noise generating activities should be planned during OPD hours. The construction site is located very close to consultation rooms. The Contractor should discuss and schedule the activities in consultation with the hospital authorities.
5. Site drainage should be planned. Rainwater drains of existing buildings should not be damaged or blocked. In addition, the rainwater drains should be incorporated into designs of the new building.

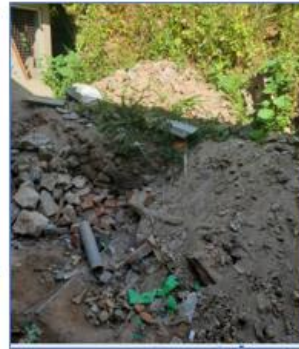
6. Demolition work has been completed but the demolished building materials and debris are yet to be removed. Brickwork of the first floor has been complete. The patients are inconvenienced due to construction work, until the new construction work and renovation work are completed.

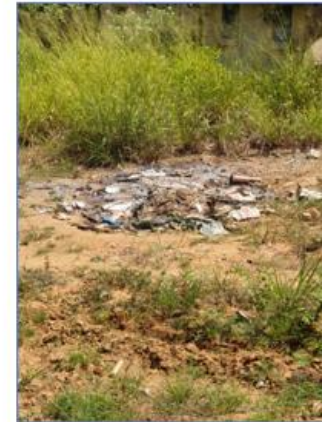
9. Open burning of waste should be avoided.
