Initial Environmental Examination

July 2018

Sri Lanka: Health System Enhancement Project

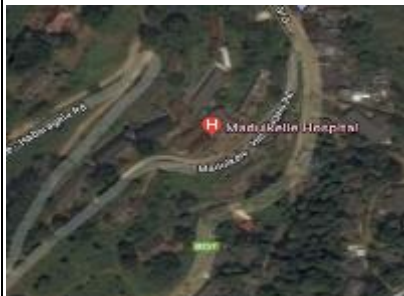
Kandy	
Madulkelle DH (B)

This hospital is located by the side of the Madulkelle – Habaragala road. The terrain is hilly and slopes into a valley beyond the road (hospital and other structures are located on the slope). The land within the hospital is sloping and the buildings are in terraced levels. The land use in the immediate surrounding is built and has several shops and houses. Soil erosion and minor landslides could be potential threats based on the topography.
Galaha DH (C)

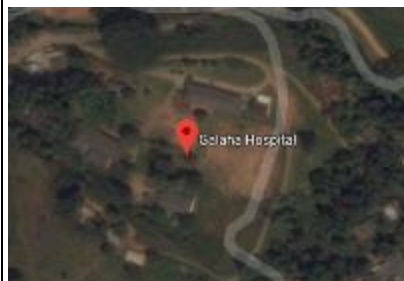
The hospital is located about 500-750 m away from the Galaha town (about 19 Km from Kandy city) on the Delthota waththa road off B364. The land in the general area is hilly and has mixed development with largely rural features. The land in the hospital is flat and large with ample space for expansion and storage of material. Soil erosion could be a potential threat during construction.
Delthota DH (B)	The DH is located about 250 m from the small rural township of Delthota. The terrain is hilly with deep valleys and the land-use in the surrounding consists of built up area with mixed development interspersed with smallholder tea gardens and overgrown bare land. Soil erosion and minor landslides could be potential threats based on the topography.

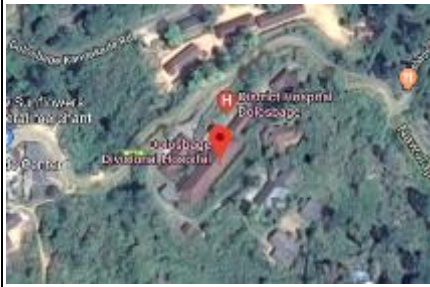
<p>Dolosbage DH (C)</p>

<p>The DH is located by the side of the Nawalapitiya – Dolosbage road. The terrain is hilly with mild to steep slopes. Land use in the surrounding are similar to other DHs described above – rural landscape with low building density and small-scale tea gardens interspersed. Soil erosion and minor landslides could be potential threats based on the topography.</p>
<p>Hataraliyadda DH (C)</p>

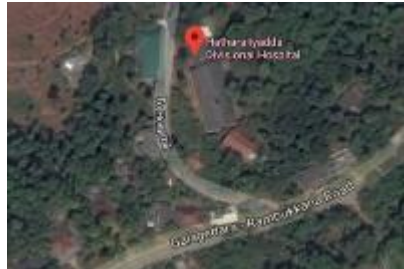
<p>The DH is located by the side of the main Galagedera – Rabukkana road. The terrain and land use in the area is similar to descriptions above with slightly higher building densities.</p>

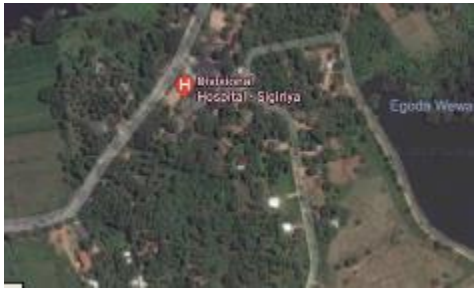
Matale	
<p>Kimbissa DH (C)</p>

<p>The DH is located by the side of the Inamaluwa – Sigiriya road. The terrain is flat and the land use in the surrounding is typical rural township with mixed development and moderate building densities. There are a couple of village tanks in the area and paddy fields nearby. No major environmental sensitivities are noted.</p>
<p>Kalundawa PMCU</p>	<p>Kalundawa is about 10 km from the Dambulla town and is predominantly agricultural landscape. The PMCU is in a typical rural setting with village dwellings, homesteads and paddy in the general area.</p>
<p>Madawala Ulpatha PMCU</p>	<p>Madawala is located about 65 Km from Dambulla on the Jaffna-Kandy highway. The terrain is slightly undulating, and the land use shows a pre-dominantly mixed development especially along the road corridor. The land of the PMCU is flat and there is ample space for the proposed development.</p>

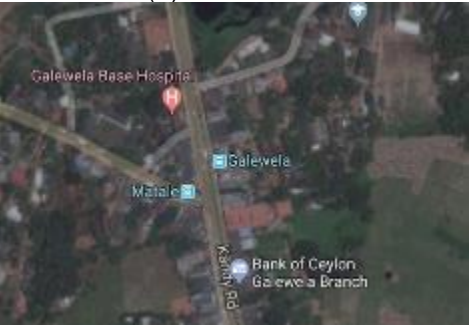
<p>Galewela DH (B)</p>

<p>This DH is in Galewela town on the Kandy road. The terrain is flat and the land-use in the immediate surroundings of the hospital is predominantly built mixed with commercial activity. Paddy fields are also seen in the background. No major environmental sensitivities are noted there is ample space for the proposed development.</p>

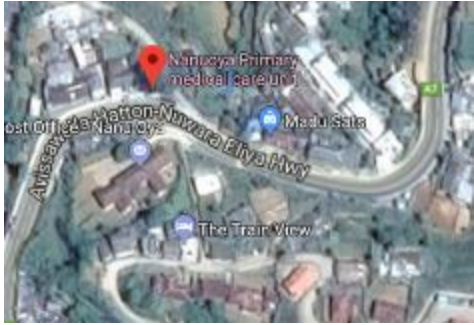
Nuwera Eliya	
<p>Nanu Oya PMCU</p>

<p>Nanu Oya PMCU is in Nanu Oya town which is one of the main towns in the district. The terrain of the area is hilly, and the land-use is predominantly built interspersed with tea plantations. Soil erosion and minor landslides could be potential threats based on the topography.</p>

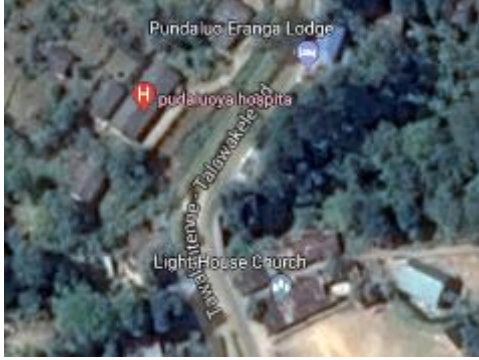
<p>Pundalu Oua PMCU</p>

<p>The PMCU is located by the side of the Talawatenna – Talawakele main road. The terrain of the area is hilly, and the land-use is predominantly built interspersed with tea plantations. Soil erosion and minor landslides could be potential threats based on the topography.</p>
<p>Lindula DH (B)</p>

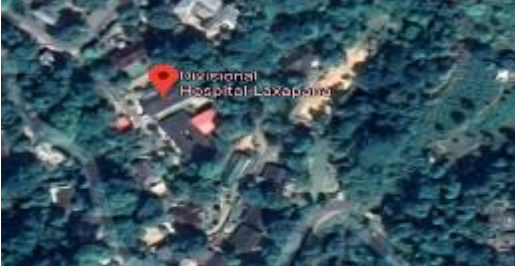
<p>The hospital is in a rural landscape with low to moderate building densities along the road corridor. The area receives high rainfall and has a wet tropical climate and thick vegetation. Given hilly terrain soil erosion could be an issue but other than that no major environmental issues are for seen.</p>

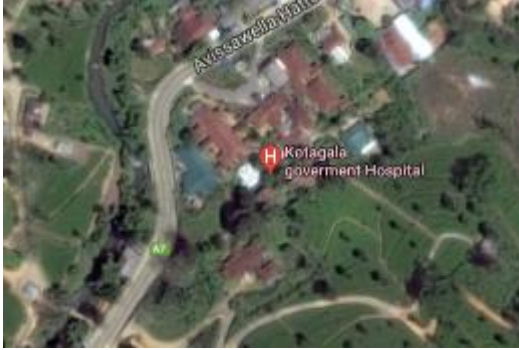
<p>Katanga DH (B)</p>

<p>The DH is located by the side of the main Colombo-Hatton main road about 250 m away from the Kotagala town. Although the general terrain of the area is hilly and predominant with tea plantations, the hospital is located on flat land. No major environmental sensitivities have been noted.</p>

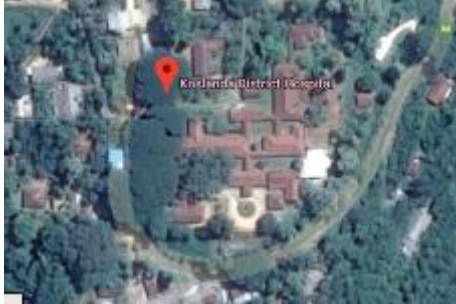
<p>Koslanda DH (B)</p>

<p>The DH is located by the side of the main Colombo - Ratnapura near the township of Koslanda. The surrounding land use consists of moderately built up area, especially along the road corridor. There are no surface waterbodies in the close vicinity or known ecological and archaeological resources. Soil erosion and landslides could be a potential threat in the area although there were no obvious signs. No other major environmental sensitivities have been noted.</p>
<p>Haldamulla DH (C)</p>	<p>The DH is located by the side of the main Colombo-Haputale main road. The land belonging to the DH is constrained and has little capacity for expansion. The area is hilly with steep slopes and the surrounding land use consists of the road and built up area. There are no surface waterbodies in the close vicinity or known ecological and archaeological resources. Soil erosion and minor landslides could be potential issue given the hilly terrain. No major environmental sensitivities have been noted.</p>

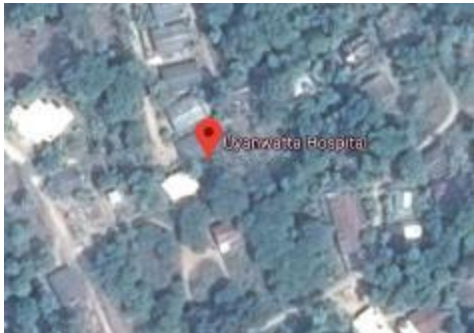
The Uyanwatte PMCU is located within the village of Uyanwatte south east of the Kegalle town. The surrounding land use consists of densely built up area. There are no surface waterbodies in the close vicinity or known ecological and archaeological resources. Soil erosion and landslides is a potential threat in the site and there were signs of collapsing soil banks behind the facility.
Aranayake DH (A)	Hospital is in close vicinity to the main Aranayake – Mawanella main road in a built-up area. The land is large and relatively flat. In the rear section is doctor's quarters built about 100 years ago by British colonialists. The building is occupied to date. The hospital management is concerned about unhindered movement of wildlife such as Wildboar in and out of the property as there is no perimeter fence.

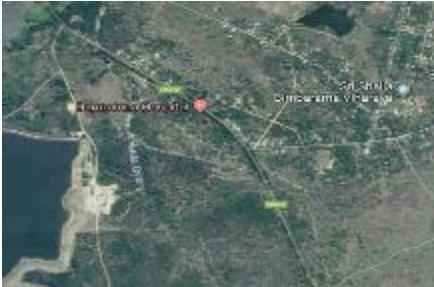
Dammina PMCU is located about 50-100 m away from a little township by the side of a main road. The land-use in the immediate surrounding consists of bare land with secondary vegetation mixed with large trees, typical of inhabited rural areas. There is a healthy line of large trees on either side of the road. The land is flat and large, and no environmental sensitivities are observed.
Sevenapitiya PMCU

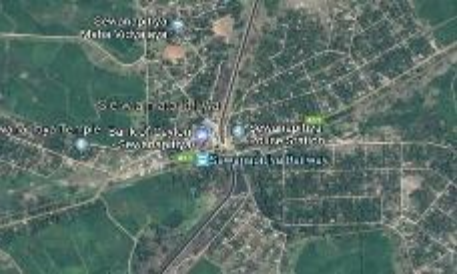
Sevenapitiya PMCU is in a similar environment to Dammina by the side of a provincial road. The land is flat and large with ample space for expansion. The staff observed that wild elephants roam in the area and sometimes enter the property of the PMCU. There is no perimeter fence right around the property.

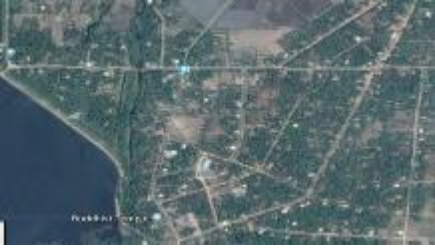
<p>Ambagaswewa PMCU</p>

<p>The PMCU is in the village of Ambagaswewa. The landscape is typically rural, dominated by paddy fields, village tanks and widely scattered homesteads/village dwellings. No environmental sensitivities are observed.</p>
<p>Aranaganwila DH (B)</p>

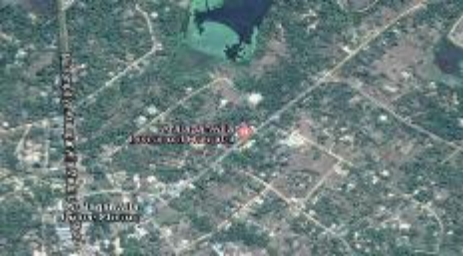
<p>This hospital is near the Aralaganwila town, off the main Aralaganwila-Manampitiya-Maduru Oya road. The terrain of the area is flat and the land-use in the immediate surrounding consists of dwelling units, homesteads and secondary vegetation. There are two small village tanks within about 500 m from the site. No environmental sensitivities are observed.</p>

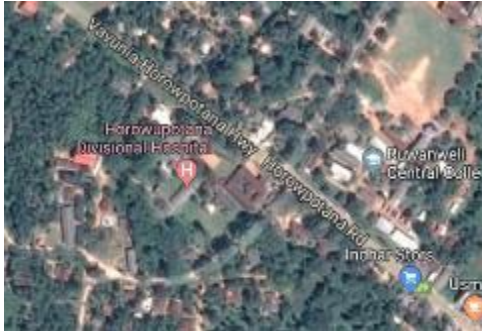
Anuradhapura	
<p>Horowupotana DH (B)</p>

<p>The DH is in the rural township Horowupotana by the side of the main Vavuniya – Horowupotana road. The terrain is flat, and the general land use consists of mixed built up zone as the area is part of the Horowupotana town. There are extensive paddy fields in the area and about 250 m behind the hospital is the Horowupotana village tank, no significant environmental sensitivities are observed.</p>
<p>Galenbindunuwewa DH (B)</p>

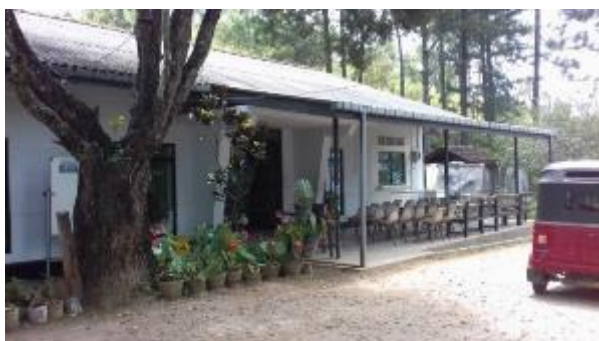
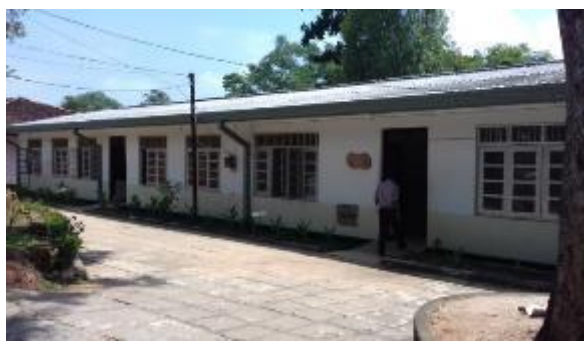
Some images of PHC facilities in the current package using AC sheets (Hambegama DH, Ettampitiya DH, and Meegahakiwula DH)

Under HSEP, renovation of PHC facilities that will generate AC sheets will not be disposed of in an irresponsible way. The following note is a further guide to the provisions contained in the EMP for the safe handling and disposal of used AC sheets.

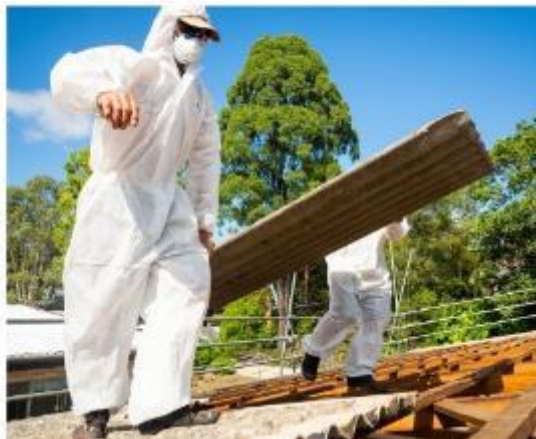
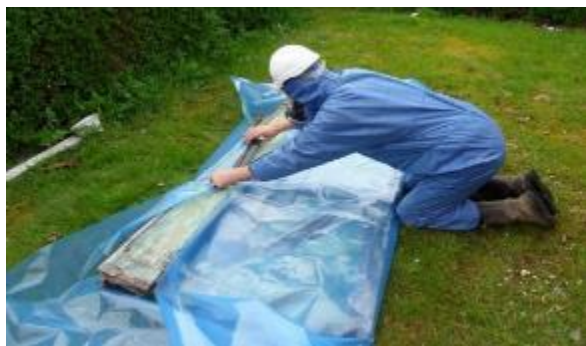
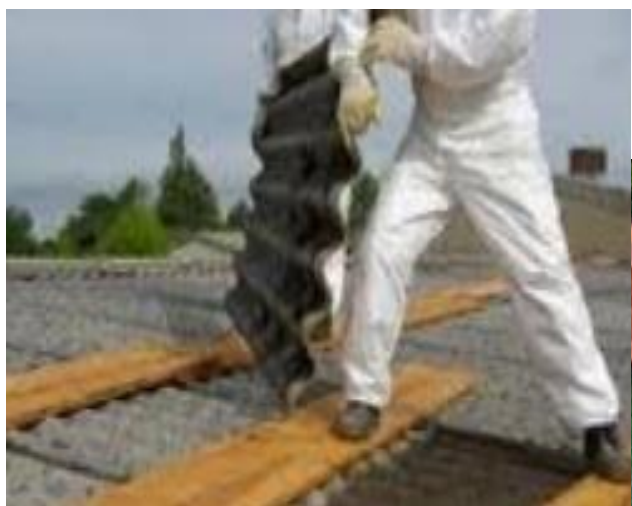
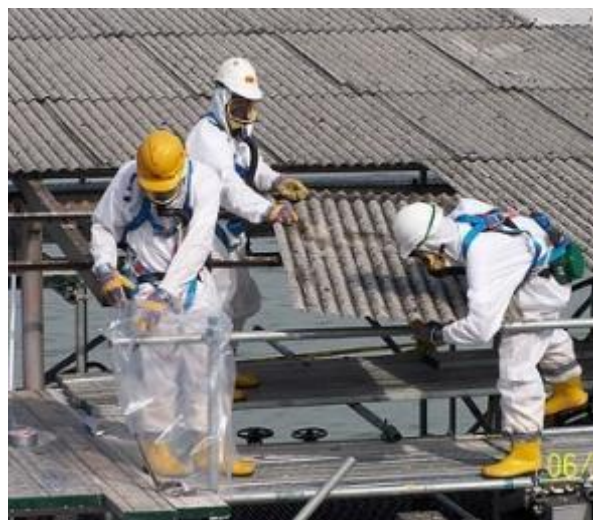
- 1 – Safe wrapping of removed asbestos in thick polythene
- 2 – Construction workers wearing full PPE
- 3 – Asbestos bags
- 4 – Walking on AC sheets can crack them and release fiber into the air. Here they use plans to walk on
- 5 – Using a mobile platform to remove the sheets minimizing the risk of breaking up AC sheets

- Clean the equipment and the area with damp rags.
- Check for debris in fasteners or bolt holes. Clean with damp rags.

- Put debris, used rags, polythene sheeting and other waste in the asbestos waste bag and tape it closed.
- Dispose of contaminated webbing and rope
- Put the asbestos waste bag in a clear polythene bag
- For disposal of the discarded AC sheets;
 - Store the sealed asbestos sheets in a container and transport to a central disposal yard where they will be stored.
 - Transfer to the sanitary landfill at Ararat in 2019
